NORWICH RESERVOIR NO. 2 DAM

**CHENANGO COUNTY, NEW YORK
INVENTORY No. NY 349**

**PHASE I INSPECTION REPORT
NATIONAL DAM SAFETY PROGRAM**

NEW YORK DISTRICT, CORPS OF ENGINEERS
MAY 1981

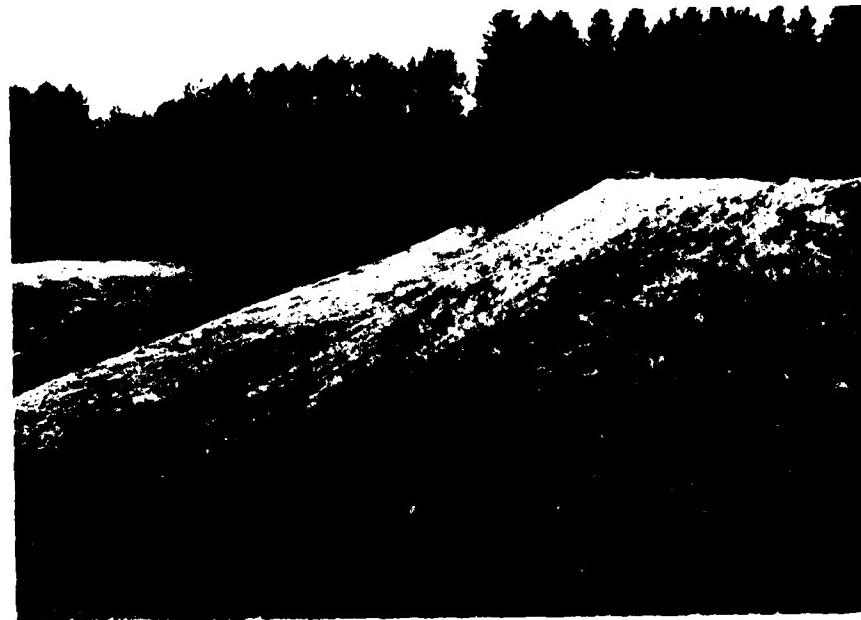
The earthfill embankment of the dam is generally in good condition (See Photos No. 4, 5, 6 and 7). The dam crest is also in good condition except for vehicle ruts and shallow depressions and is presently used for access to Norwich Water Works Dam No. 1 (See Photo No. 3). There was no visible evidence of lateral movement, seepage, major settlement or erosion, or other serious defects.

1. Several minor surface sloughs were observed on the right side of the upper downstream slope.
2. Several large animal burrows were noted on the upper portion of the downstream slope. Several small animal burrows were observed near the crest on both the upstream and downstream slopes (See Photo No. 18).
3. Moderate to large-sized spruce trees are growing on the downstream slope along the left and right abutments; this tree cover overlaps onto the downstream embankment slope on the left side (See Photos No. 5 and 7).

PHOTO #5: Overview of downstream face of dam

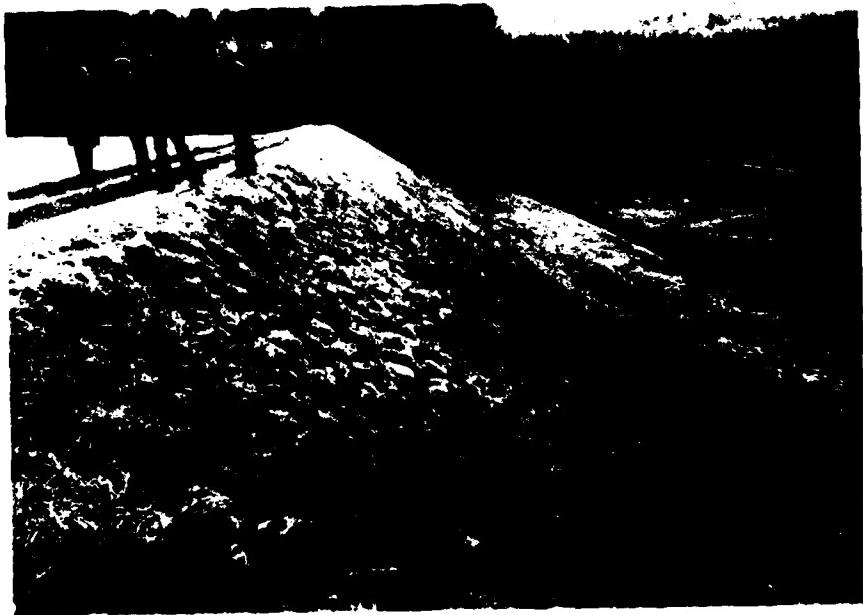
PHOTO #7: Downstream face of dam

1. Remove all spruce trees that are growing between the crest and lower berm on the left side of the downstream embankment slope and also any whose trunks or roots may be encroaching onto the right side of the embankment. The trees growing on the abutments may remain. The trees to be removed constitute a potential hazard if uprooted during a storm. This may lead to a loss of freeboard, to a dangerous reduction of embankment width, or to the formation of piping channels if uprooted and the remaining roots rot in place.

2. The trunks of all cut trees are to be removed and backfilled. Equipment and procedures for this maintenance operation should be such as to avoid damage to existing grass and weed cover on the slopes. Any slopes that become scarred by runoff or traffic should be reseeded and mulched.

- a. Remove all spruce trees that are growing between the crest and lower berm on the left side of the downstream embankment slope, and also any whose trunks or roots may be encroaching onto the right side of the embankment. Trees growing on the abutments may remain. The trees to be removed constitute a potential hazard if uprooted during a storm. This may lead to a loss of freeboard, to a dangerous reduction of embankment width, or to the formation of piping channels if uprooted and the remaining roots rot in place.

- b. The trunks of all cut trees are to be removed and back-filled. Equipment and procedures for this maintenance operation should be such as to avoid damage to existing grass and weed cover on the slopes. Any slopes that become scarred by runoff or traffic should be reseeded and mulched.

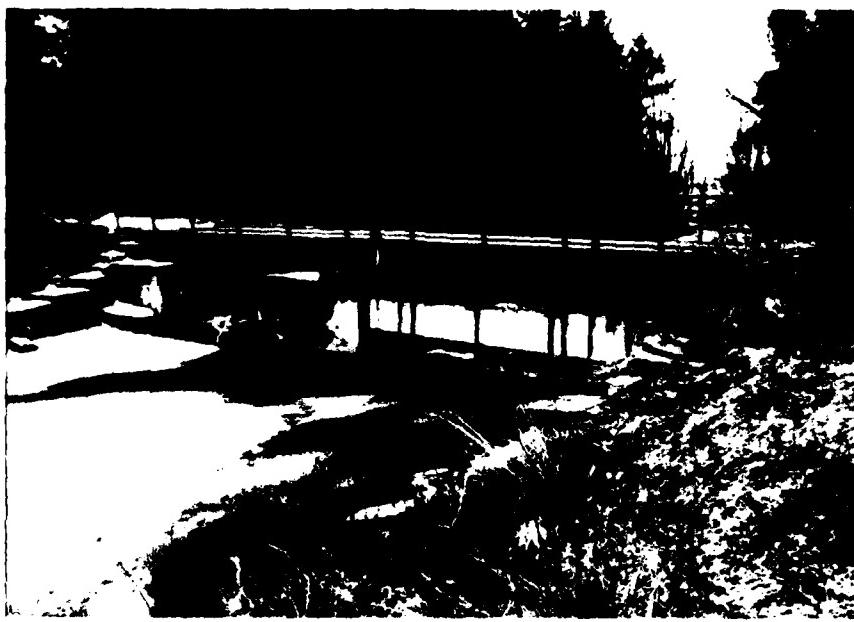
This two-stage broad-crested weir is constructed of cut stone masonry and concrete and is in good condition. The lower stage contains provisions for 2.5 foot high adjustable flashboards. The approach channel to the weir is straight, free from debris and also in good condition (See Photo No. 8). A 50 foot long by 13 foot wide bridge spans the spillway weir (See Photo No. 8) and is used for access to the lower reservoir, dam and chemical feed building. It has two spans constructed of steel I-beams, a steel grate

deck and a 3 foot high pipe rail parapet (See Photo No. 8).

PHOTO #8: View of principal spillway from upstream

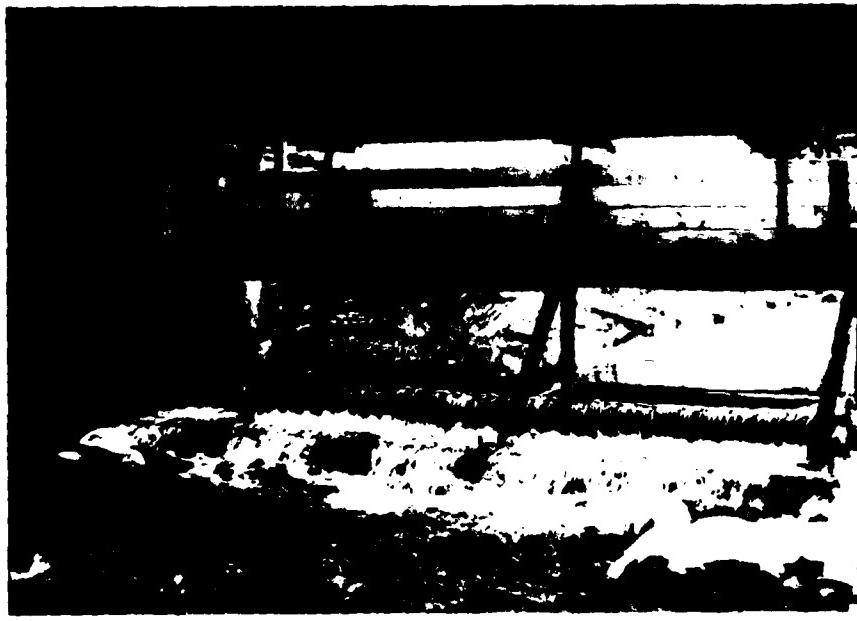
Visual inspection of the Norwich Reservoir No. 2 Dam was conducted on March 13, 1981. The weather was overcast and the temperature was 40°F . At the time of the inspection, there were small patches of snow on the ground and water was flowing in the principal spillway (See Photo No. 9).

PHOTO #9: Closeup of flashboards from downstream

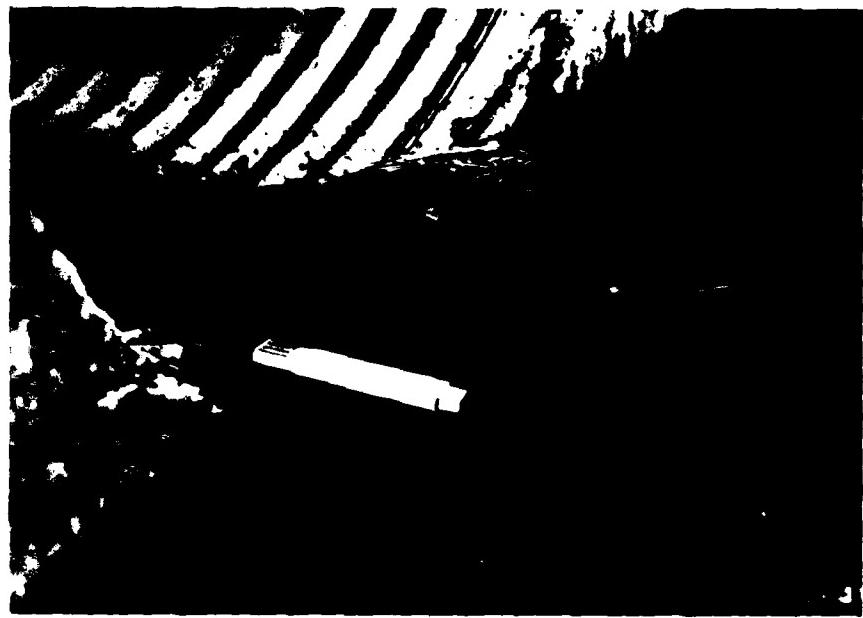
PHOTO #11: Seepage through joint between concrete headwall and apron

3. Patch the cracks in the concrete apron and repair the separation between the concrete headwall and apron of the emergency spillway inlet to prevent water from flowing up from beneath the apron.

- c. Patch the cracks in the concrete apron and repair the separation between the concrete headwall and apron of the emergency spillway inlet to prevent water from flowing up from beneath the apron.

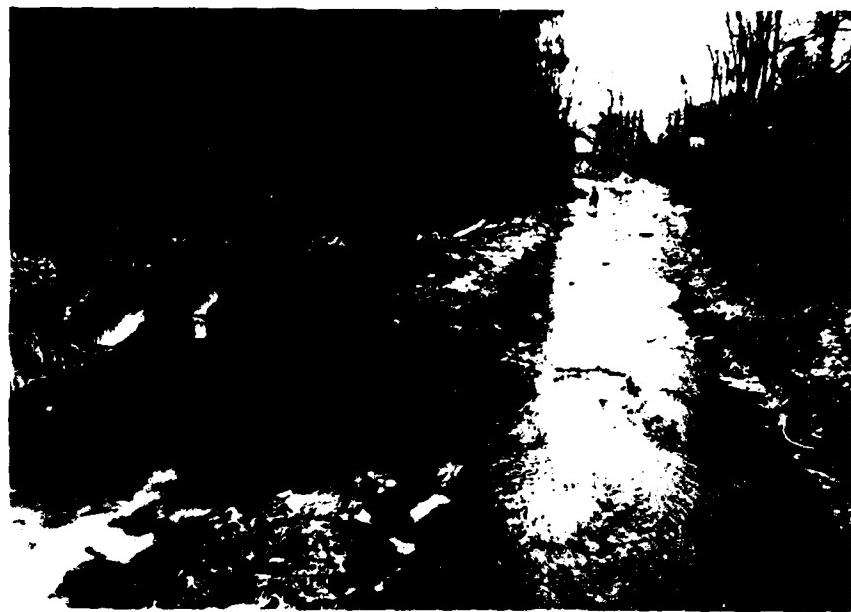
The discharge channel has a typical width of 45 feet, a length of approximately 2400 feet and is in good condition (See Photo No. 12). This channel directs flow around both this dam and the lower dam (NY 347). The side slopes of the channel vary from 0.5 horizontal to 1 vertical to 2:1 and are excavated into bedrock in some sections. Portions of the left side slope are formed by an earthen berm.

PHOTO # 12: Outlet of emergency spillway and downstream channel conditions

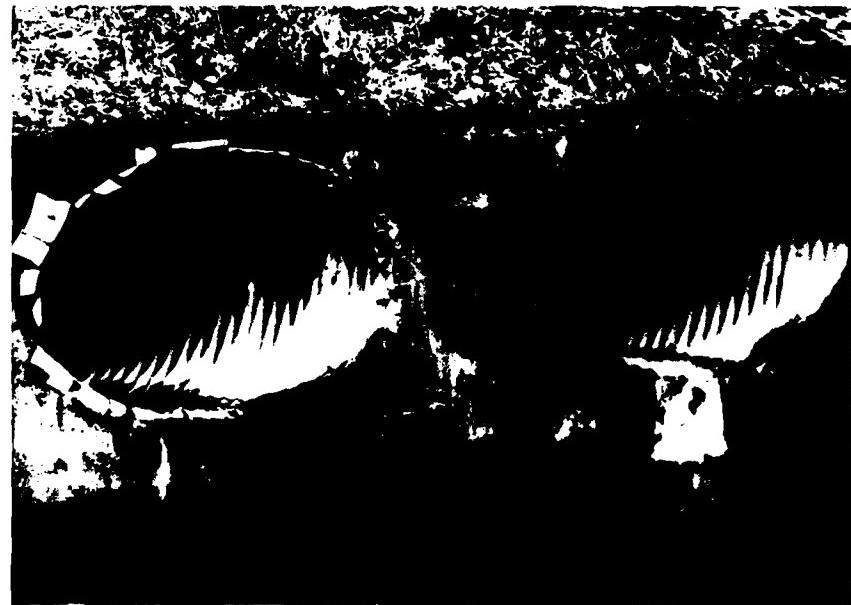
PHOTO #13: Closeup of emergency spillway outlet

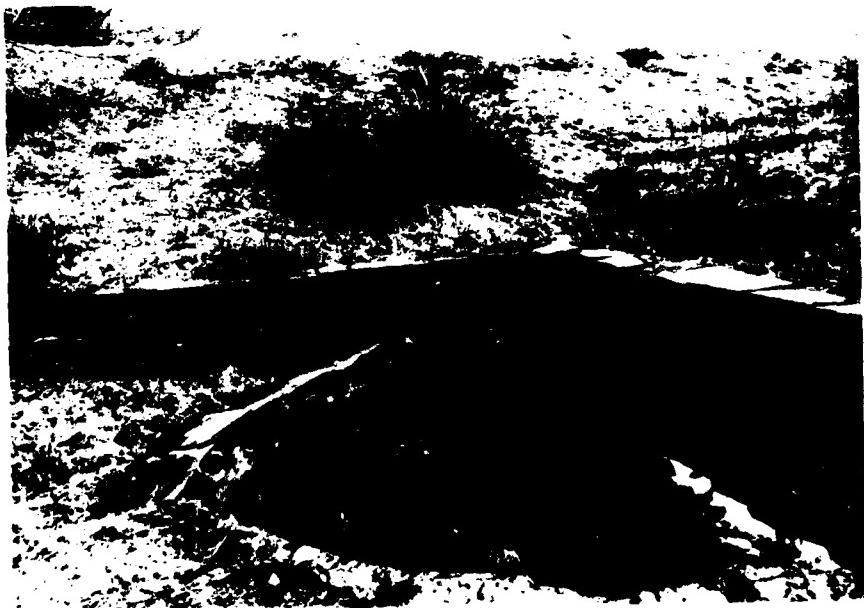
The primary outlet works is a 36 inch diameter cast iron water supply pipe located between the intake structure and the stilling basin (See No. Photo 15). Connected to this pipe is a 12 inch diameter cast iron pipe which supplies water to two 4 inch diameter cast iron discharge pipes (See Photo No. 16), to the aerating jets of the lower reservoir and to the City of Norwich water distribution system. Additionally, a 14 inch diameter cast iron pipe serves as a drain for the stilling basin emptying into the lower reservoir (See Photo No. 17). The pipe networks for the upper and lower reservoirs are shown on a "Sketch Map" on page D-17 in Appendix D.

PHOTO #15: Outlet works (36" cast iron
pipe - CIP)

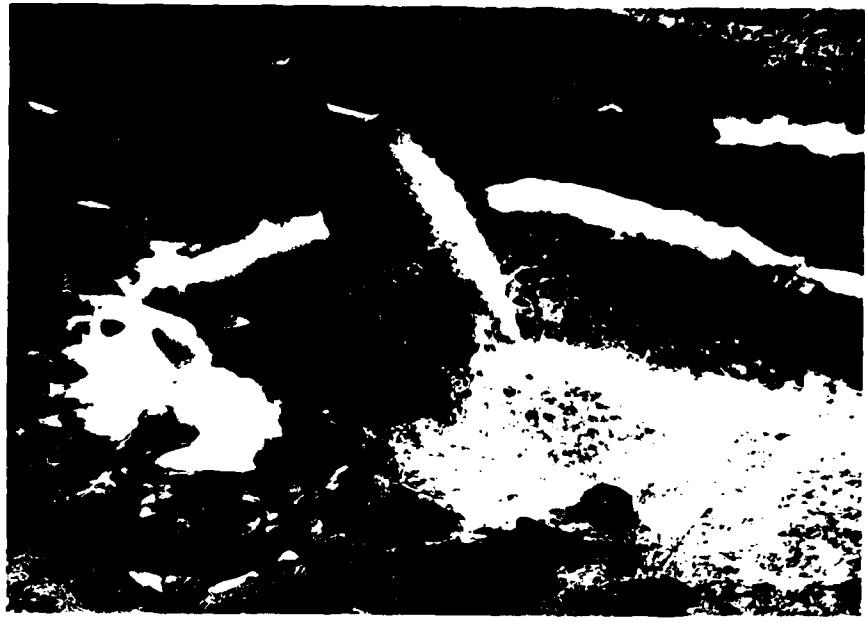
PHOTO #16: 4" CIP outlet pipe flowing
nearly full

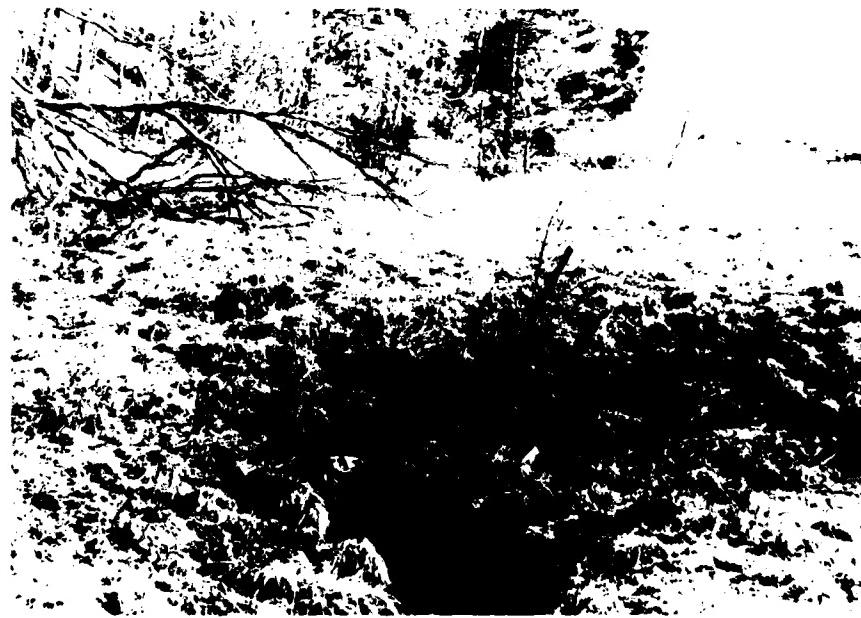
PHOTO #17: 14" CIP drain from outlet works
(shown in Photo #15)

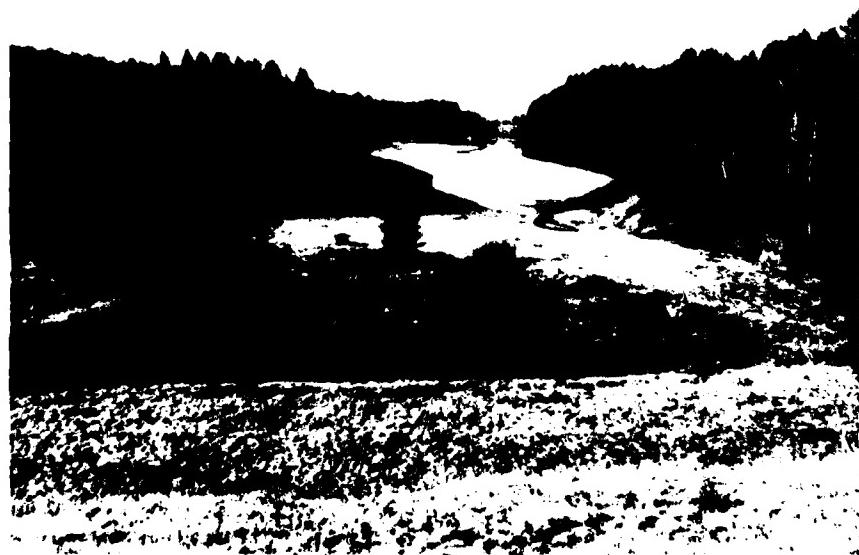
The only natural channel downstream of the dam is located at the end of the bypass canal below the lower dam and reservoir. It has a width of 10 to 15 feet and a depth of 6 inches. Immediately downstream of the upper dam is the lower reservoir and dam - NY 347 (See Photo No. 19).

PHOTO #19: Downstream channel conditions -
impoundment for Norwich Water Works
Dam No. 1 (Inventory No. NY 347)
